## ASTM F-710, Does the Subfloor Need to be THAT Flat?

January 6, 2016

Reggie Hill

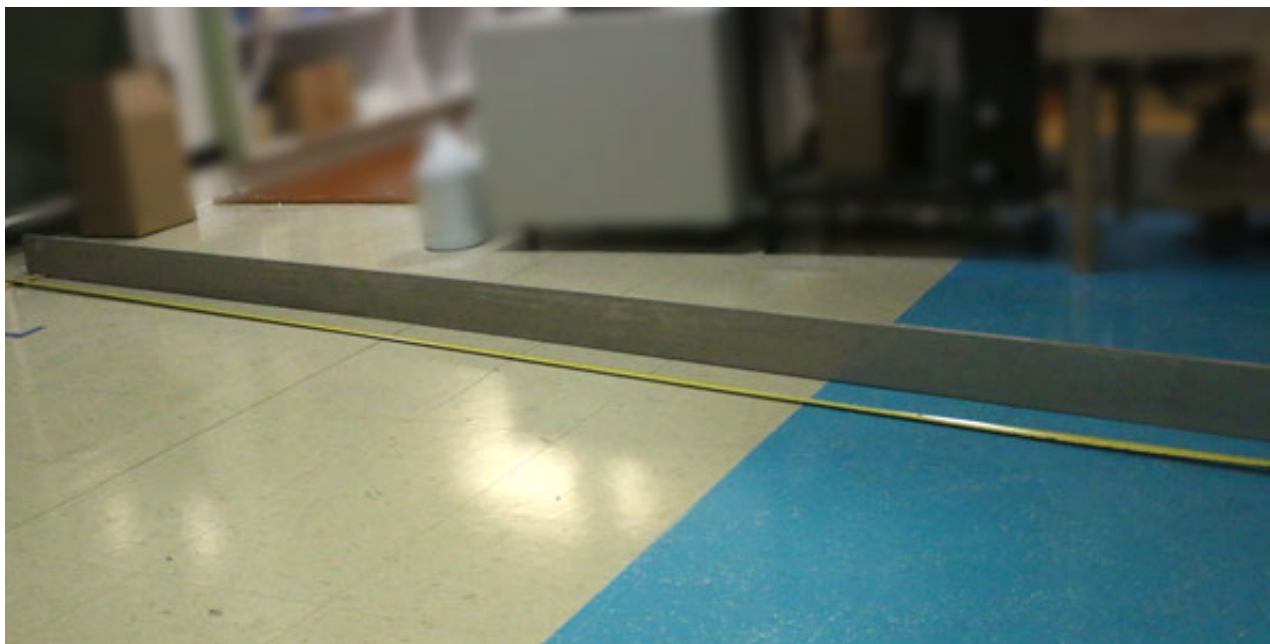
*Photo 1: 10-foot Straight-edge used to gauge flatness of floor.*

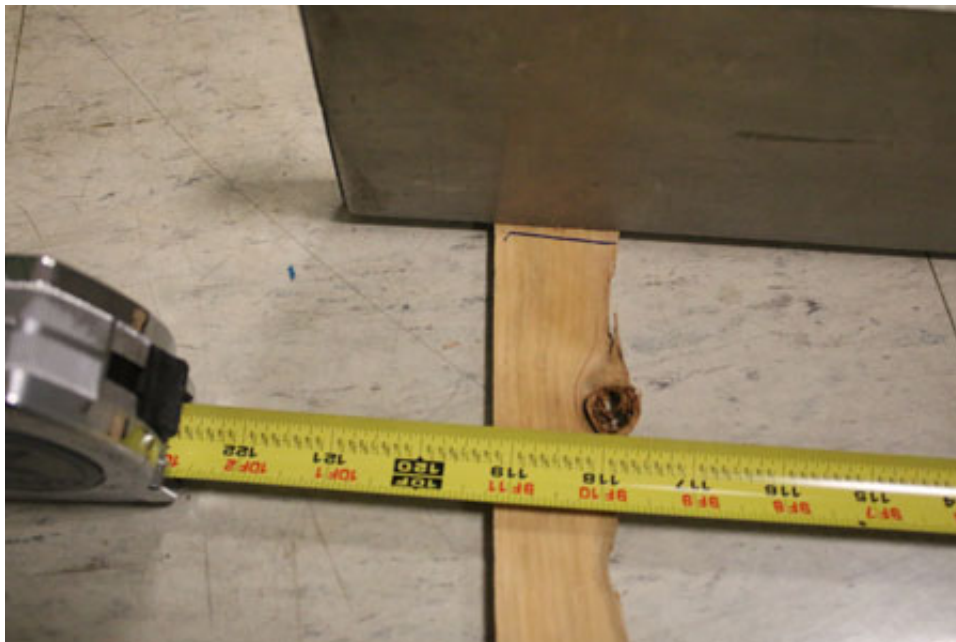
*Photo 2: Plywood shim replicates maximum acceptable 3/16" deviation in height.*

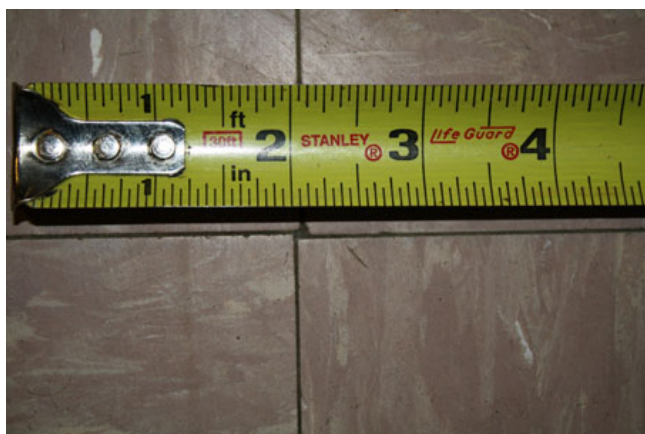
ASTM Standard F710 is a straight forward rule however a quick audit of hard-surface flooring installations indicates that most installers do not provide provisions to accommodate this ASTM standard during installation. The result can be seen in **Photos 3, 4 and 5.**

*Photo 3: VCT run off and gaps at joints.*

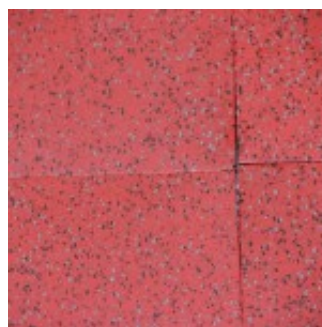
*Photo 4: Rubber floor tile run-off, gapping at seams.*

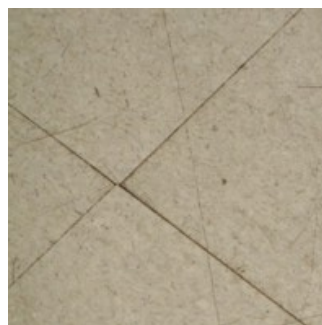
*Photo 5: Flooring tile with severe runoff.*

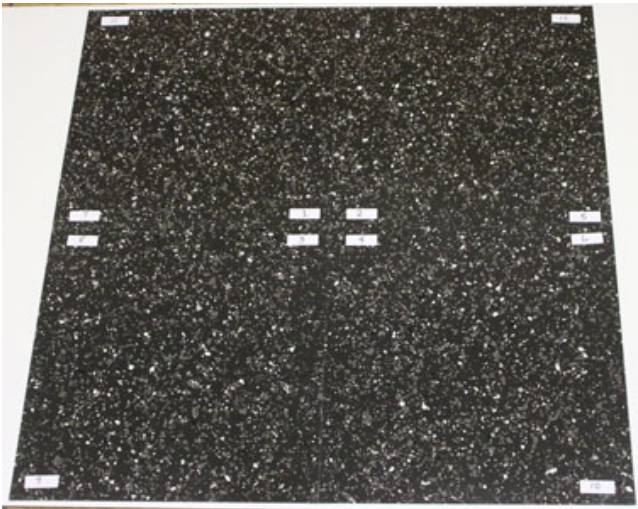
In order to simulate the outcome of resilient flooring tiles installed over a flat subfloor that complies with ASTM F710, I set up, labeled and outlined in pencil, a group of four tiles over a flat subfloor surface as shown in **photo 6.** To

*Photo 6: Set up of 4 tiles laid on a flat subfloor with tight joints and the perimeter traced.*

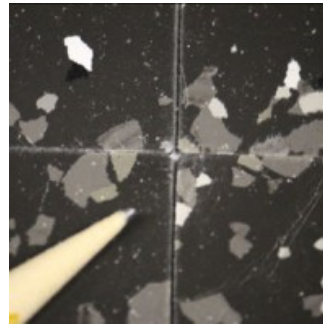
demonstrate what happens when there is a hump in the concrete sub floor, I placed a 3-and-one-half inch bump under the 2x2 foot floor tiles. **Photo 7** shows that the joints are no longer tight and **photo 8** reveals a deviation from a net fit where the uneven subfloor caused the tile pattern to pull away from square. When this happens across the span of a room, cutting tiles and increasing or skewing joint lines is necessary to counteract the runoff caused by an unprepared underfloor. This is often an eyesore and results in claims and complaints from customers to the company that makes the flooring.

*Photo 7: After simulating bump in subfloor, evident opening at joints.*

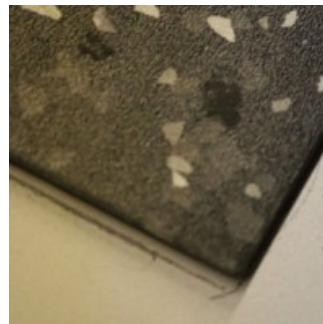
*Photo 8: With 3-1/2" subfloor deviation, tile alignment shifts drastically.*

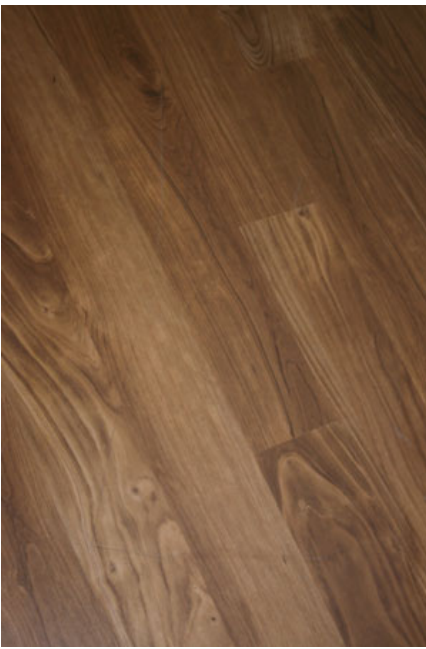
As you can see in **Photo 9**, when the floor meets the Standard set by ASTM F710, the modular flooring is not defective as it visually provides an acceptable finished appearance -that the manufacturer had envisioned when designing, engineering

*Photo 9: LVT installation meets ASTM-710 Standard for flat subfloor.*

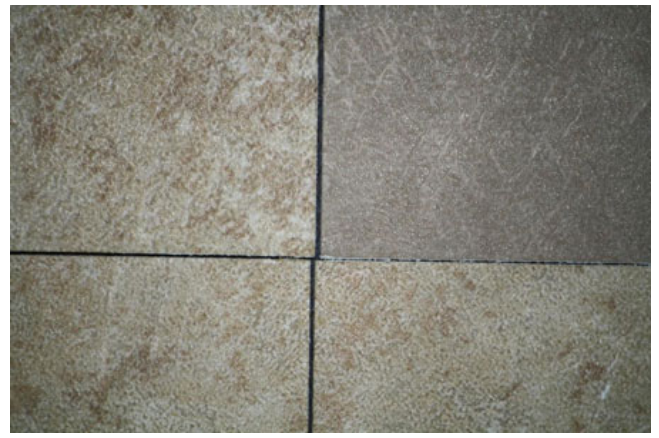
**Photo 10** discloses the immediate problems created when a floor does not comply with this Standard due to a severe hump in the underfloor. Close inspection of the photograph reveals modular components that veer to the left and to the right making it impossible to navigate the hump without gaps and misaligned corners. Even the best flooring installer cannot overcome severe undulation unless they even out the problem areas of the subfloor prior to laying the floor tiles.

The bottom line...installed floors that do not conform to ASTM Standard F 710 are not a manufacturing defect, they are the direct result of poor workmanship or failure to follow the flooring manufacturer's printed installation instructions. It is important to know that the smaller the format of the modular flooring, the more difficult and challenging it will become to install the flooring with tight net joints in both directions and without runoff. Often in severe situations, a flooring installer may be tempted to

*Photo 10: Result of severe underfloor humps.*

Replacing a floor can be expensive... especially when the flooring manufacturer is not participating in the cost so take the time to resolve sub floor issues before flooring is installed
